# MOTORCYCLE IMPACTS TO ROADSIDE BARRIERS – REAL-WORLD ACCIDENT STUDIES, CRASH TESTS AND SIMULATIONS CARRIED OUT IN GERMANY AND AUSTRALIA

Paper Number 05-0095

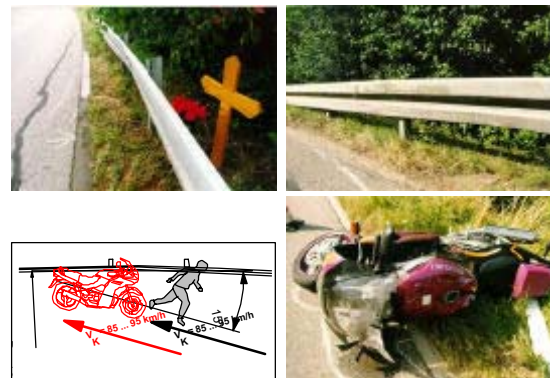
An example of a real-world crash is given in Figure 2. The motorcycle was driven around a left-hand bend. Its speed was reconstructed to be in the range of 85 – 95 km/h. The driver lost control and the motorcycle tilted onto its side. This was followed by an impact of the motorcycle with the rider sliding on the road surface onto the roadside protection system. The protection system is a so called “einfache Schutzplanke” ESP (see Figure

1.). The profile of its posts is similar to the Greek letter S (Sigma). Therefore the post is called a “Sigma Post”. The rider’s neck directly impacted the post. It is reported that he suffered severe injuries (AIS 5) such that his neck was broken directly underneath neck vertebra C1. He also suffered internal injuries from additional impacts. The motorcyclist died after the accident.

**Figure 2. Example of a real-world crash**

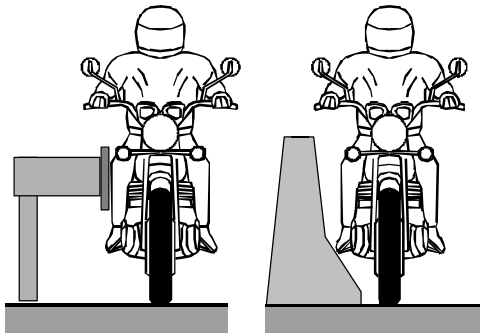
**Figure 3. Test where the motorcycle impacted the barrier in an upright driving position**

Two impact scenarios were chosen for the full-scale crash test program as a result of the findings from the real-world crash study. In the first impact scenario the motorcycle was driven in an upright position (Figure 3) prior to impact. In the other scenario the motorcycle struck the barrier while skidding on its side (Figure 4).

For all crash tests the pre-crash velocity of the motorcycle was 60 km/h. For the impacts where the motorcycle was driven upright the angle between its velocity vector and the barrier was 12°. For the impacts where the motorcycle skidded on the ground the angle between its velocity vector and the barrier was 25°.

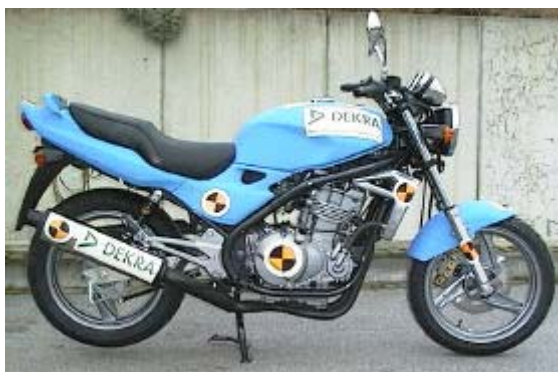
All tests were carried out with the same make, model and type of motorcycle being a Kawasaki ER 5 Twister (Figure 5.). The mass of the motorcycle itself was approx. 180 kg and approx. 272 kg with the dummy sitting on the motorcycle and wearing standard protective clothing.

**Figure 5. Motorcycle Kawasaki ER 5 Twister as used for all crash tests**

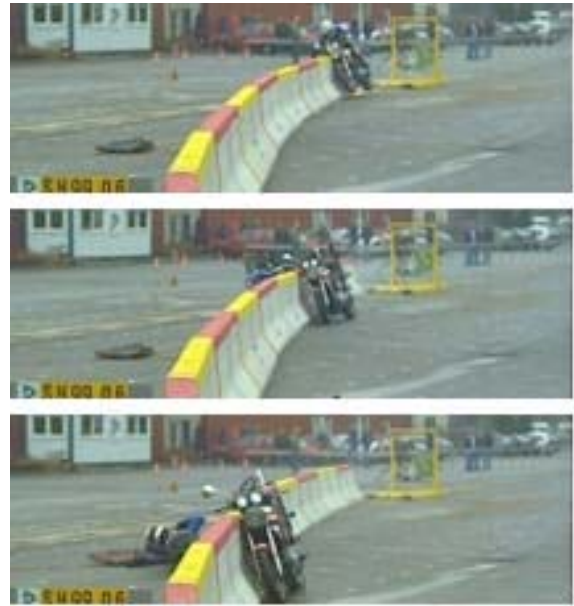
The concrete barrier (Figure 8) does not have any aggressive open shaped parts as in the case of the steel-based systems. In this crash test the motorcycle left the sled at 60 km/h prior to impacting the barrier. This was followed by the dummy flying over the top of the barrier. The dummy reached its final rest position on the opposite side of the barrier (Figure 8 and Figure 9). The distance of the final rest position from the point of first contact primary impact location was 26 m for the dummy and 38 m for the motorcycle.

**Figure 8. Full-scale crash test of a motorcycle impacting a concrete barrier protection system in an upright position prior to impact moving**

The measured dummy loads again do not indicate any life-threatening injury risk (see Table 2.). The right femur is subjected to a compressive load of 4.5 kN being clearly below the injury limit of 10 kN.

Analysis of the film revealed that the motorcycle and the rider were effectively not decelerated during contact with the concrete barrier. As a consequence of this the risk of being deflected by the barrier into oncoming-traffic on the road is clearly higher than for a barrier protection system made from steel. Another disadvantage of concrete barriers is that during an impact they do not dissipate as much kinetic energy via deformation as the systems made from steel.

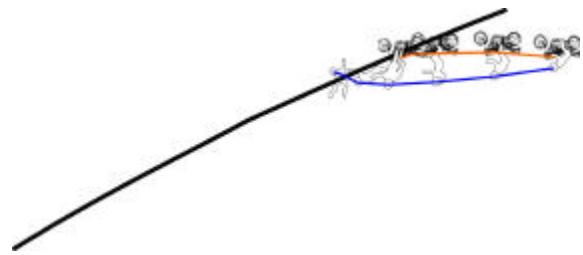
Figure 11 shows the trajectories of the motorcycle and dummy before and after impact onto the

protection system as determined from the analysis of the film from the overhead-view cameras.

**Figure 11. Trajectories determined from the overhead-view cameras of the motorcycle and the dummy before and after impacting the steel guard rail (Figure 10)**

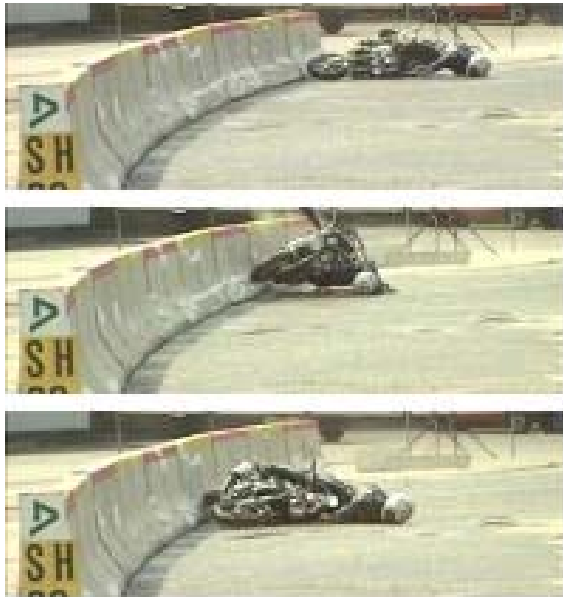
The impact where the motorcycle slides onto its side into the concrete barrier is shown in Figure 12. The motorcycle left the sled at 59 km/h and the front wheel impacted the barrier at 46 km/h.

**Figure 12. Full-scale crash test where the motorcycle impacts the concrete barrier protection system in a sliding position**

Some of the measured dummy loads related to the point of first impact into the protection system and to the second impact onto the ground are shown in table 4.

Deceleration of the motorcycle and dummy were not as rapid as during the impact where the motorcycle slid into the guard rail made from steel. Nevertheless the measured dummy decelerations for the primary impact were high, indicating a risks of severe and life-threatening injuries. The dummy head loads again lay clearly above the corresponding biomechanical limits.

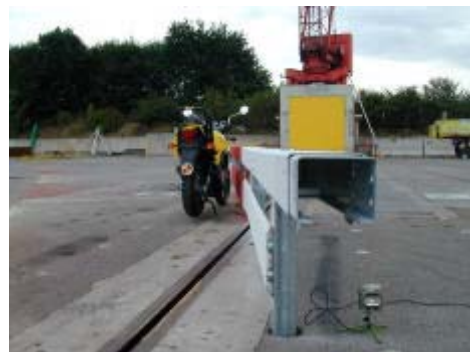
Figure 14 provides some information in regards to structure and the geometry of the modified system. The system is a so called “Schweizer Kastenprofil” consisting of sigma posts and a closed box-shaped profile at the top. An additional underrun protection board was mounted near to the ground to prevent both the direct impact onto a post and movement of the motorcyclist underneath the barrier protection system.

**Figure 14. Modified guard rail system with respect to better protection for impacting motorcyclists**

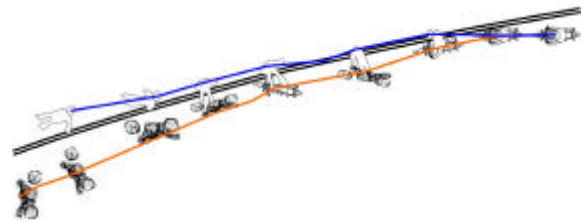
The trajectories of the motorcycle and dummy before and after impact onto the protection system determined from the analysis of the film from the overhead-view cameras is shown in Figure 16. The characteristics of the trajectories are similar to the corresponding crash test onto the concrete barrier (compare Figure 8 and Figure 9 to Figure 15 and Figure 16). The motorcycle reached the final rest position 23 m after initial contact primary impact. In the case of the dummy, the distance between the location of the initial primary impact and the final rest position was measured as 22 m.

**Figure 16. Trajectories of the motorcycle and dummy determined from the overhead view camera before and 230 milliseconds after impacting the modified steel guard rail system (see Figure 15)**

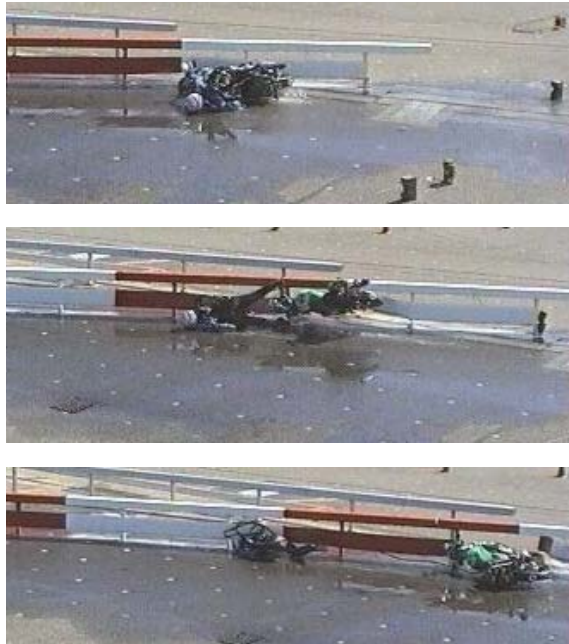
Figure 17 shows the crash test where the motorcycle and dummy slides on the road surface. The motorcycle left the sled at 60 km/h and impacted the barrier at 54 km/h. Due to the impact the underrun protection board broke and the motorcycle struck a Sigma post. The dummy separated from the motorcycle immediately after the initial primary impact and then the helmeted head struck the underrun protection board.

**Figure 17. Full-scale crash test where the sliding motorcycle impacted the modified steel guard rail system**

Table 6 gives an overview of measured dummy loads related to the primary impact and to the secondary impact. For the primary impact into the protection system all measured dummy loads were clearly less than their corresponding injury tolerance limits. However the measured 3-ms-96 g head acceleration during the secondary impact is above the tolerance limit of 80 g. Also the HIC in the secondary impact with a value of 510 but clearly beneath the limit of 1,000 is relatively severe.

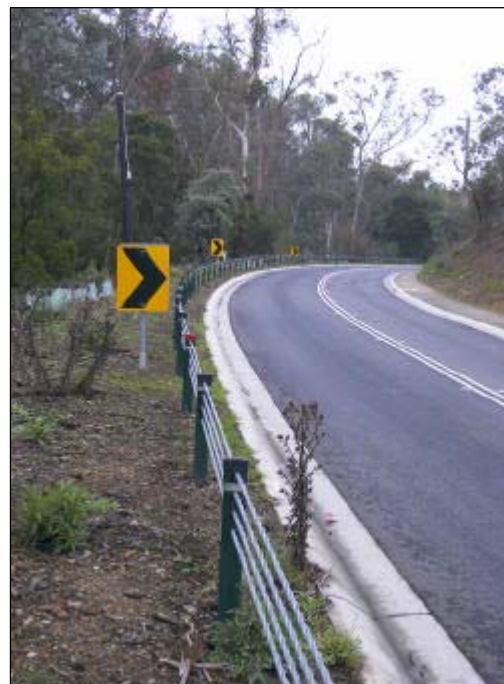
The wire rope barrier model was based on an actual installed system (Figure 20 and Figure 21). This barrier consisted of seven posts that supported the four wires of the barrier. The wires of the barrier that were modelled are made up of three high tensile steel cables woven together with an assumed yield stress of 500 MPa. They have a combined circumference of 60 mm and were represented in the model by a TRUSS2 finite element with a cross sectional area of 280 mm<sup>2</sup> for each cable. The wires had an initial tension setting of 5 kN. Ellipsoids were used to model the support posts being 2 mm thick.

**Figure 20 Four rope wire rope barrier**

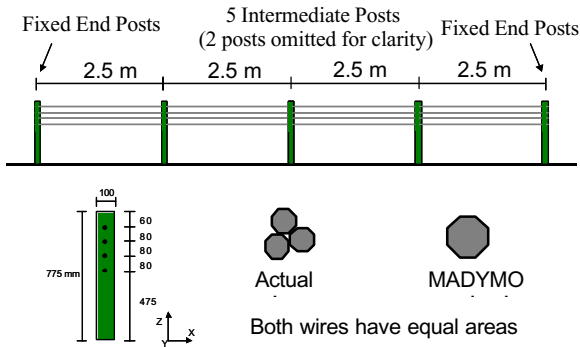
**Figure 21 Wire rope barrier simulated in MADYMO**

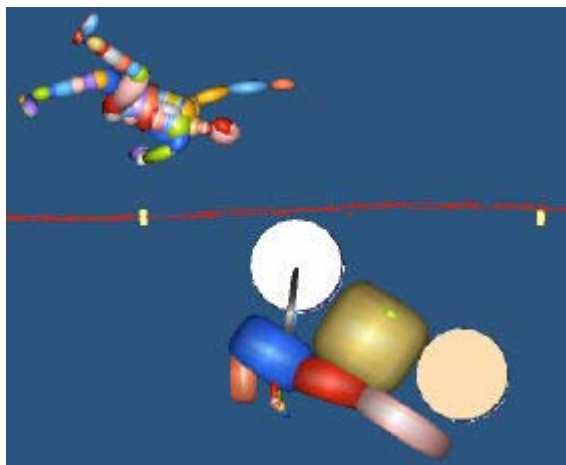
Figure 23 MADYMO simulation showing an upright seated rider on a motorcycle crashing into a wire rope barrier at 60 km/h and 12°

Figure 23 shows the kinematics for an upright rider on a motorcycle impacting a wire rope barrier. The calculated injuries from the simulations suggest that serious injury would result regardless of speed and impact angle.

In all simulations the motorcycle slides along the wires until it hits a post, squeezing and trapping the rider's leg against the wires as it does so. The post contact causes the motorcycle's front wheel to snag lifting the front of the motorcycle up and throwing the rider's torso and head forward. Because the rider's leg is trapped between the motorcycle and the wire ropes and the foot snags in the ropes, the head and torso slap into the front of the rising motorcycle. Eventually the leg becomes free as the motorcycle rotates and the rider is then catapulted over the barrier. This is a different result to the concrete barrier where the rider was thrown over the barrier with relatively little snagging or deceleration.

In both the 60 km/h and 80 km/h impact speeds at an angle of 25°, the motorbike throws the rider into the air with the rider hitting the ground head first. Hence the high HIC.
